September 13, 2019

This report summarizes the results of the mercury vapor air sampling and air monitoring conducted in the gymnasium and surrounding areas at Ocean Academy. This preliminary assessment was conducted at your request to determine if the gymnasium has a rubberized polyurethane floor that contains mercury used as a catalyst during installation. Dr. Richard M. Lynch, Ph.D., CIH and Mr. Richard A. Lynch, MBA, CIEC conducted this investigation with the assistance of Mr. Charles Yahara.

Figure #1 - August 22, 2019 Observations and Air Monitoring Findings

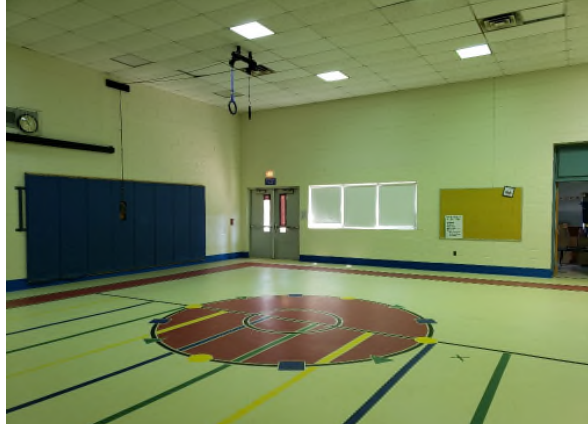
<p align="center">Gym Center 0.38 $\mu\text{g}/\text{m}^3$</p>	<p align="center">Passive Vents to Padded Wall Cavity & Green Room</p>

- Gym & Storage Areas
 - Airborne mercury monitoring with the gym measured $0.38\mu\text{g}/\text{m}^3$ in the gym center and averaged $0.35\mu\text{g}/\text{m}^3$ when measuring connected storage rooms and offices. These values are below the New Jersey Department of Health guideline of $0.80\mu\text{g}/\text{m}^3$

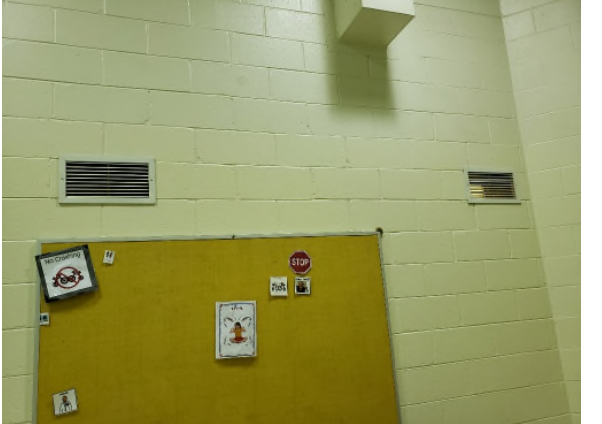
- The padded room had a similar passive vent opening shared with the gym which had been covered with the rubberized padded walls from within the padded room. Hence the passive vent from the gym terminated in the wall cavity between the gym and padded room.

- Airborne mercury monitoring conducted in the green room, adjacent to the gym and the padded room, measured $0.43\mu\text{g}/\text{m}^3$ due to a passive vent linking the green room and the gymnasium.

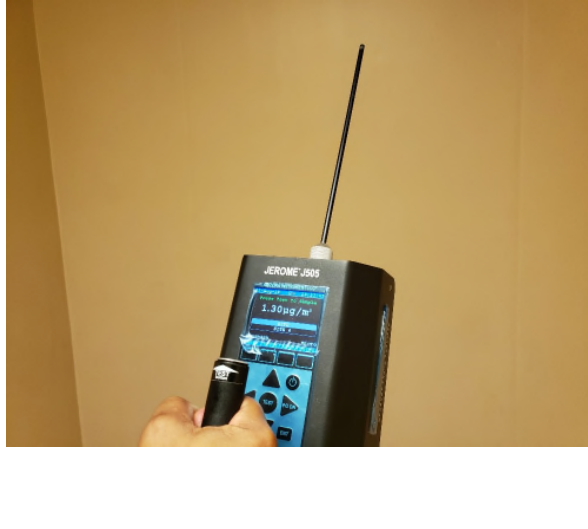
- The padded room immediately adjacent to the gym contained a rubberized gym floor-like coating on the floors and walls.

<p align="center">Padded Room 1.25–1.3 $\mu\text{g}/\text{m}^3$</p>	<p align="center">Gym-Padded Room Wall Cavity 73.66 $\mu\text{g}/\text{m}^3$</p>

- The Bulk sample composite collected from the padding in the padded room contained 460 mg/Kg of mercury. A copy of laboratory results is attached.

- Padded Room
 - Airborne mercury monitoring measured **in the Padded room** adjacent to the gym averaged **$1.25\mu\text{g}/\text{m}^3$** .
- Green Room

1. Remove the padded room from use by staff and students.
2. Install and activate an exhaust fan to remove air from the padded room discharging directly above the roof. The minimum flow rate for this exhaust fan should be 100 cubic feet per minute to render the padded that room under negative pressure with respect to the gym, hallway and green room.
3. Seal the passive vent between the padded room and gym to reduce wall cavity vapors from entering the gym.
4. Arrange for ESMCorp to conduct follow-up air monitoring with the gym and surrounding areas after steps 1-3 have been completed.

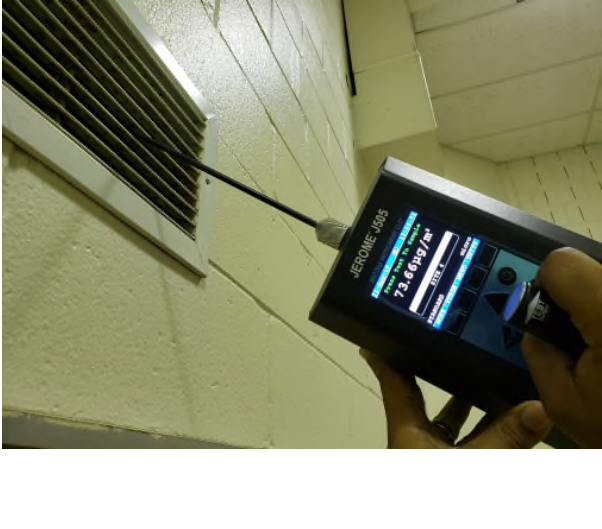
- Airborne mercury monitoring in the **wall cavity** separating the gym and the padded room ranged **between $50\mu\text{g}/\text{m}^3$ and $73\mu\text{g}/\text{m}^3$** . This appears to be a source of the low-level mercury levels detected within the gym and green room.

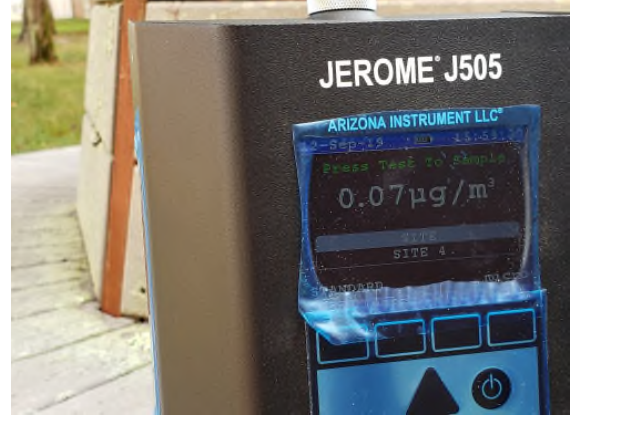
<p>Outdoors 0.07-0.11 $\mu\text{g}/\text{m}^3$</p>	<p>Gym Center 0.04 - 0.07 $\mu\text{g}/\text{m}^3$</p>

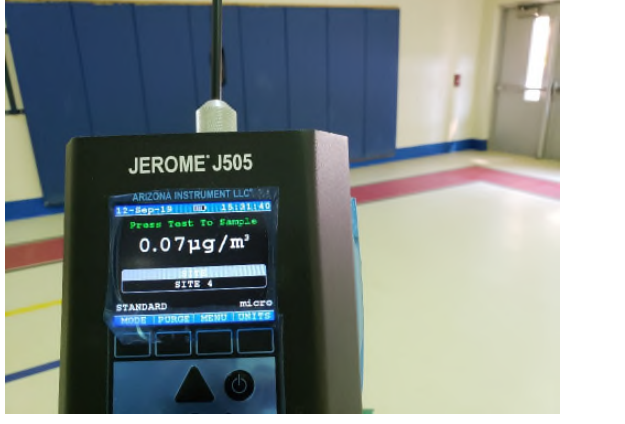
- Air monitoring findings revealed that airborne mercury levels within the gym were equivalent to outdoor levels, measured at 0.04 to $0.07 \mu\text{g}/\text{m}^3$.
- Airborne mercury levels within the green room were approximately equivalent to gym and outdoor levels at $0.08 \mu\text{g}/\text{m}^3$. Airborne mercury levels in the surrounding areas including room 101, the gym office, gym storage rooms, and the hallway outside of the gym were also equivalent to outdoor levels, ranging between 0.01 to $0.05 \mu\text{g}/\text{m}^3$.
- Based upon the above, no airborne mercury hazard is suggested within the gym or surrounding classroom or hallway areas.

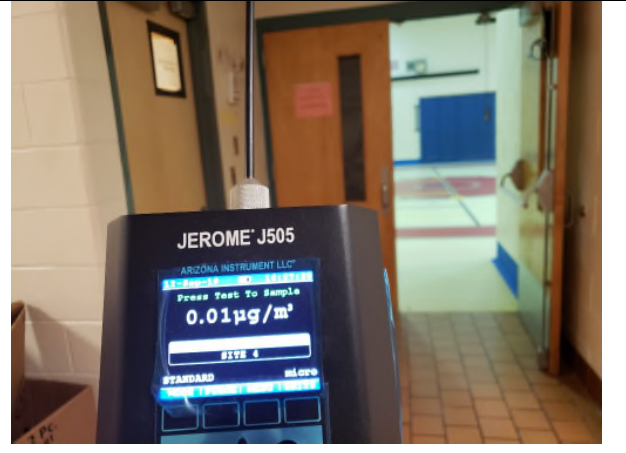
<p>Hallway Outside Gym 0.01 $\mu\text{g}/\text{m}^3$</p>	<p>101 Classroom 0.01 $\mu\text{g}/\text{m}^3$</p>

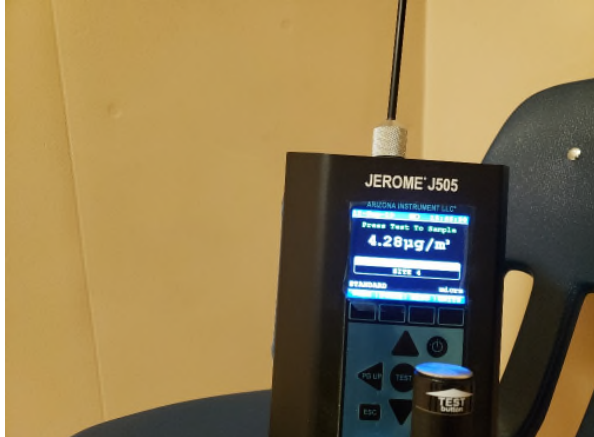
- Within the Padded Room, the newly installed exhaust fan was measured to be exhausting approximately 80 cubic feet per minute of air from the room, directly above the rooftop. This exhaust flow rendered the padded room under negative pressure with respect to the gym, hallway, and green room as anticipated. Smoke current tests confirmed that the net flow of air from the hallway to the padded room prevents escape of padded room air into the surrounding hallways and gym areas both with the gym's air handler off and while operating.

- Airborne mercury levels within the padded room, with the passive vent to the gym sealed were significantly higher than previously measured at 4.3 $\mu\text{g}/\text{m}^3$.

<p align="center">Sealed Padded Room 4.3 µg/m³</p>	<p align="center">Green Room with New Padding 0.08 µg/m³</p>

1. Continue to operate the exhaust fan within the padded room to render the padded room under negative pressure with respect to all surrounding areas.
2. Plan to remove all rubberized padding from the padded room. Because of the high mercury content of the padding, this removal should be conducted by experienced professionals, under negative pressure isolation with Certified Industrial Hygiene oversight. Waste padding and backing must be disposed as hazardous waste. Dr. Richard Lynch of ESMCorp can assist with development of a specification for this removal and arrange for experienced vendors to provide pricing.
3. Inform stakeholders of the findings of this investigation in accordance with your district's public communication policies. Dr. Lynch is available to assist with this.
4. Provide a copy of this report to an experienced Occupational/Environmental Health physician to
